REPAIR AND REINSTALLATION IN- STRUCTION FOR DEERE NO-TILL COULTER CAM ASSEMBLY

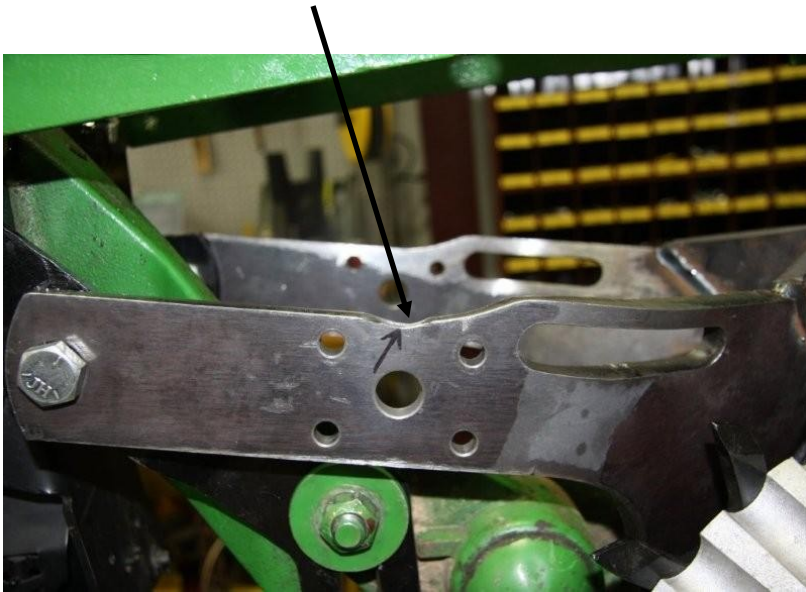
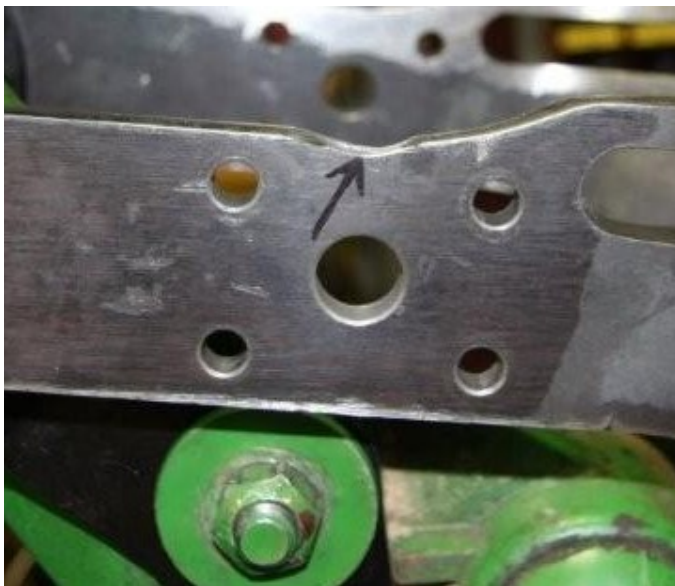
STEP 1

Grind out this area as shown for spring clearance

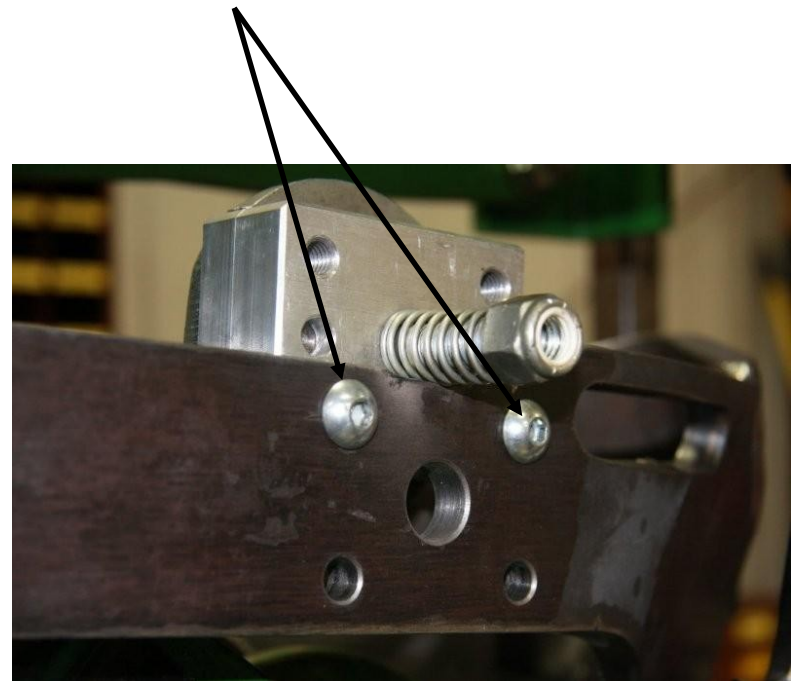
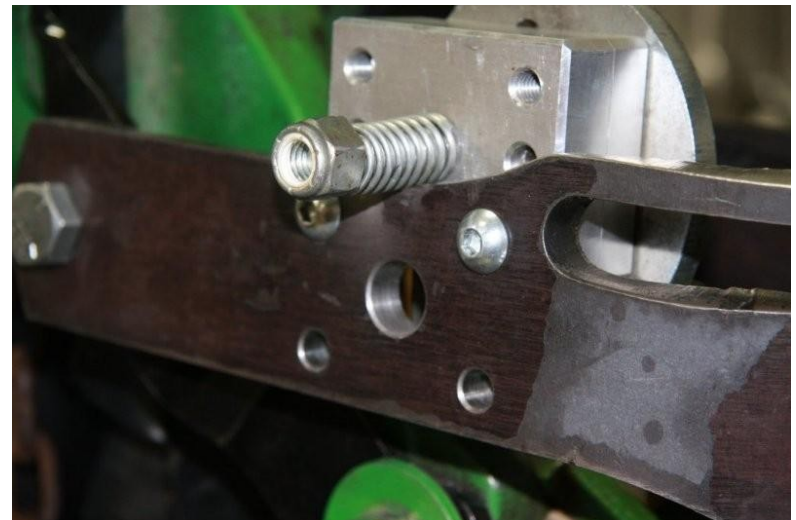
Step 2

Re-Attach cam block as shown below using the 2 holes with two 3/8 bolts and nuts
